# ICELANDIC TURF BUILDINGS: FLOOR FORMATION PROCESSES AND THE INTERPRETATION OF ACTIVITY AREAS

## **2.2 ETHNO-GEOARCHAEOLOGICAL CASE STUDY: ÞVERÁ, LAXÁRDALUR**

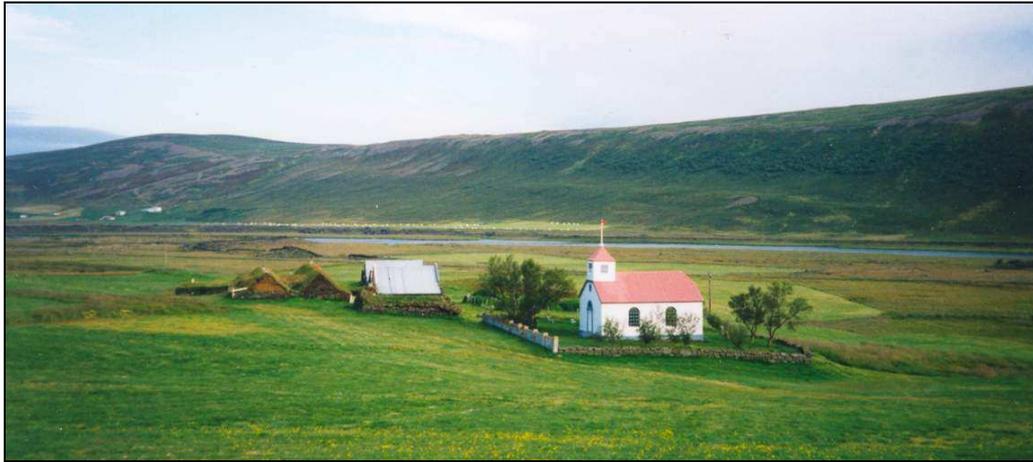
**Figure 2.2** Þverá facing northeast, showing the nineteenth-century house (left), the church (right), and the Laxá river in the background.

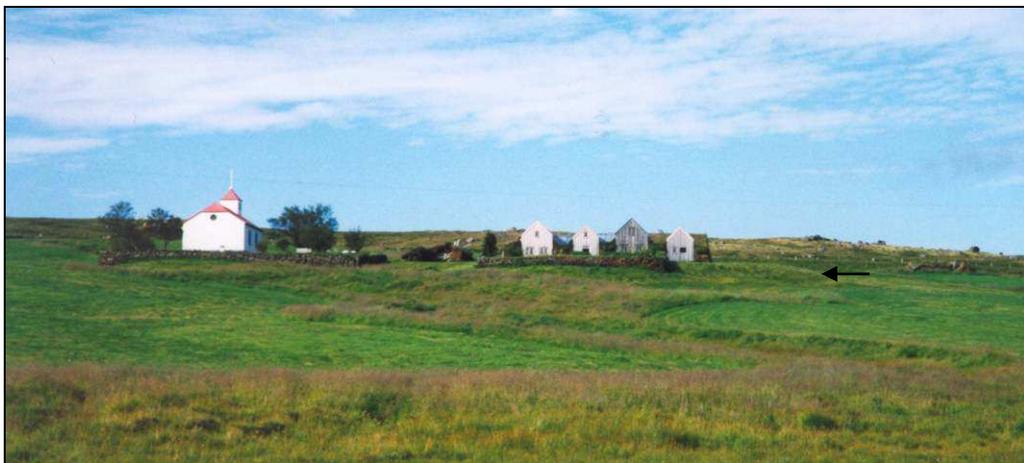
**Figure 2.3** Þverá facing west, showing the location of the turf house on top of the older farm mound (arrow).

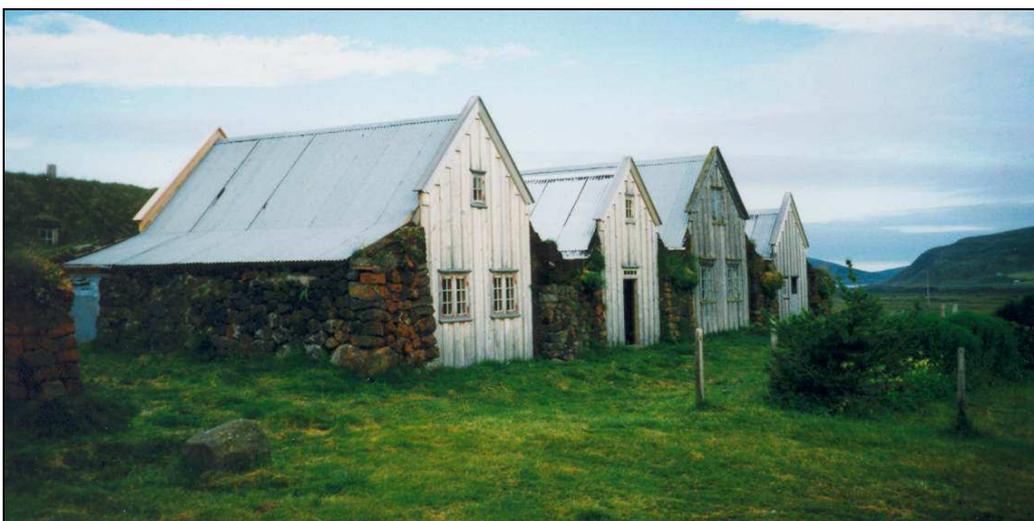
**Figure 2.4** The house facing northwest, showing the four front rooms, each with its own wooden gable, a fashion typical of the nineteenth and early twentieth century.

The standing turf house at Þverá was built in 1852 and was continuously occupied until its abandonment in 1960, when the residents of the house moved into a modern concrete building c. 70 m to the south (Áskell Jónasson, pers. comm.). The turf house was then used in a limited way as a storage facility until it was taken over by the National Museum of Iceland in 1965. At that time, the parts of the house that had fallen into disrepair (e.g. the smithy) were rebuilt, and the debris that had accumulated since abandonment was cleaned out. Áskell Jónasson, the farmer who had been born in the bedroom of the turf house in 1938 and had lived there until its abandonment, was commissioned by the National Museum to undertake the necessary upkeep of the walls and the roof, but otherwise to disturb the house as little as possible. He laid fresh turf over the floors of the house in order to 'make them nice' for visitors, which had the fortuitous effect of sealing and protecting the floors from any further disturbance. Although the house is open to the public, visitation is low because the farm is quite far from the major roads, and visitors have probably had a negligible impact on the house and its floor deposits. The likelihood that the floor sediments were well preserved, and the availability of a reliable informant who was willing to talk about what daily life had been like inside the turf house, made the site ideal for the investigation of floor formation processes.

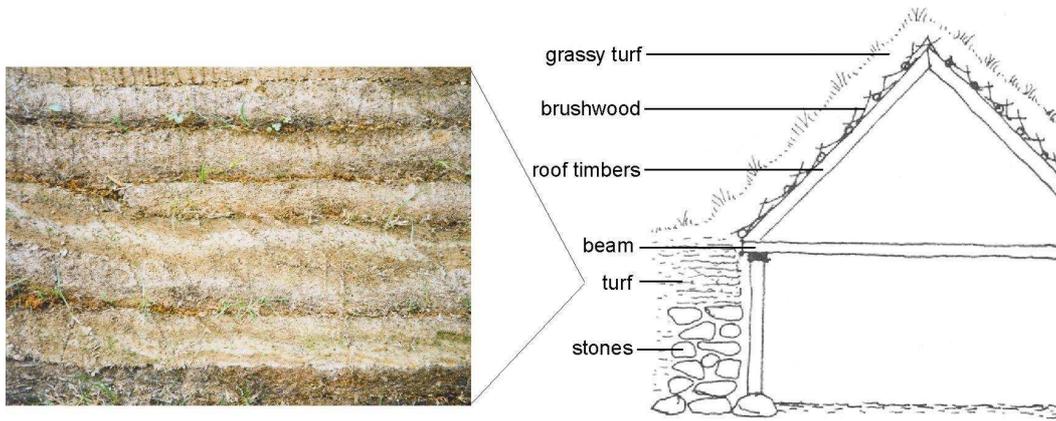
**Figure 2.5** Schematic section of the kitchen at Þverá, showing the construction of the walls and roof (from Olesen & Kjær 1972, 35), and a close-up of a turf wall (left). The stripy aspect of the wall was produced by the redistribution of iron as the turf dried out.

At Þverá, the main part of the house had two separate roofs, each with its own ridge line (Figure 2.6). The roofs were supported by rows of posts resting on stone post pads positioned along the inner edges of the walls (Figure 2.5). The roof timbers were covered by a mat of birch and willow brushwood, on which were laid long strips of turf (c. 40 x 150 cm) that were pegged down to prevent them from slipping (Figure 2.8). With the grass side of the turf facing upwards, the roof absorbed the rainfall and the grass remained alive and green (Figure 2.7). Gísli Gestsson (1982) noted that the pitch of the roof was normally adjusted according to the amount of rainfall received in a particular area, with a pitch of lower than 45° in drier regions and higher than 45° in rainy areas, where it was advantageous to promote runoff. Nineteenth-century ethnographic sources record that during the hay harvest the grass on the roof was mowed with a scythe (Henderson 1818), and I observed this practice myself in 1998.

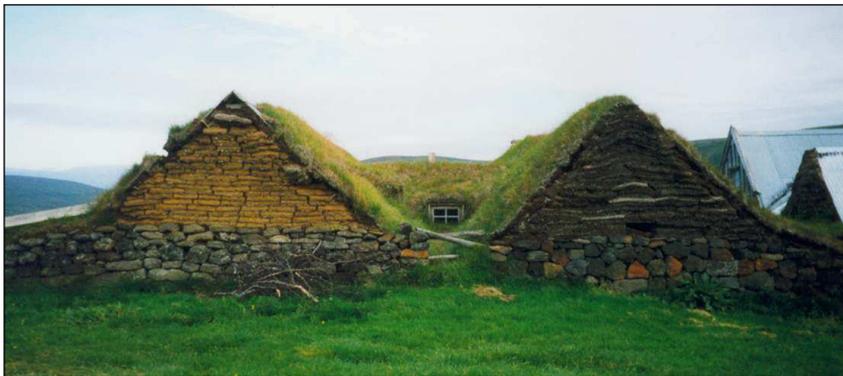
**Figure 2.6** The house facing north, showing the separate roof ridges of the rooms. Two different sizes and shapes of turf building material can also be seen – *kvíahnaus* on the left and the longer *strengur* on the right.

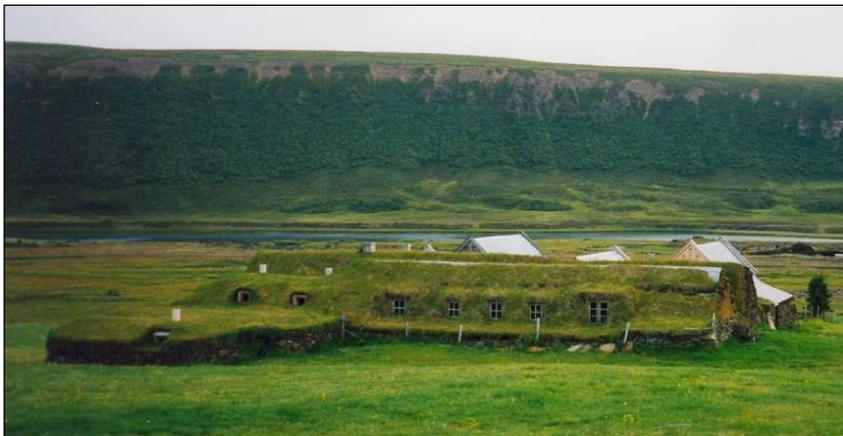
**Figure 2.7** The back of the house, facing east, showing the grassy roof, from which light holes protrude. The glass windows in the bedroom and sitting room were a later addition. The low room on the left side of the house caps a small stream, and was used to keep milk cool.

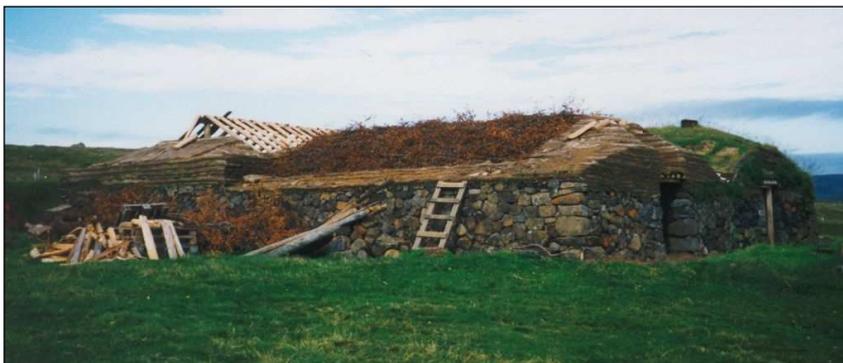
**Figure 2.8** Turf roof of sheephouse 1 (right) and attached hay barn (left) undergoing repair. A mat of birch brushwood has been laid on top of the timber roof beams, in preparation for the grassy turf that will be laid on top.

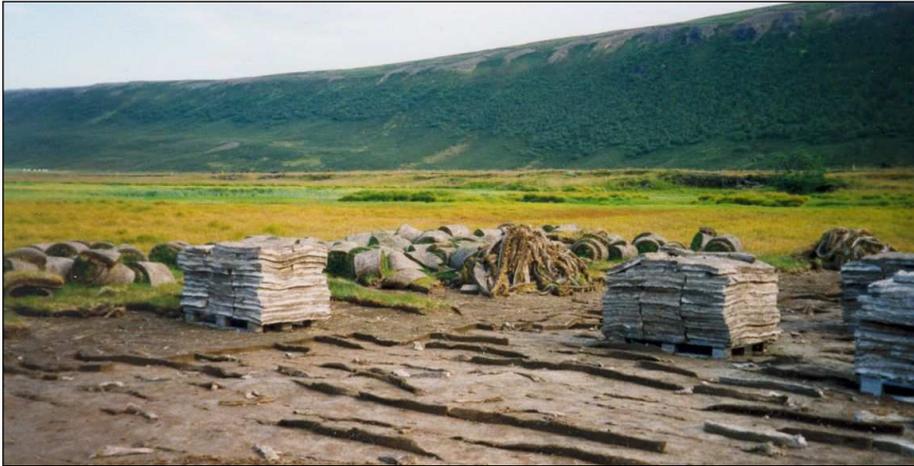
**Figure 2.9** Turf cutting east of the house. Long strips of grassy turf have been rolled up and placed to the side, while strips of the less coherent, lower turf have been stacked on pallets for easier transport.

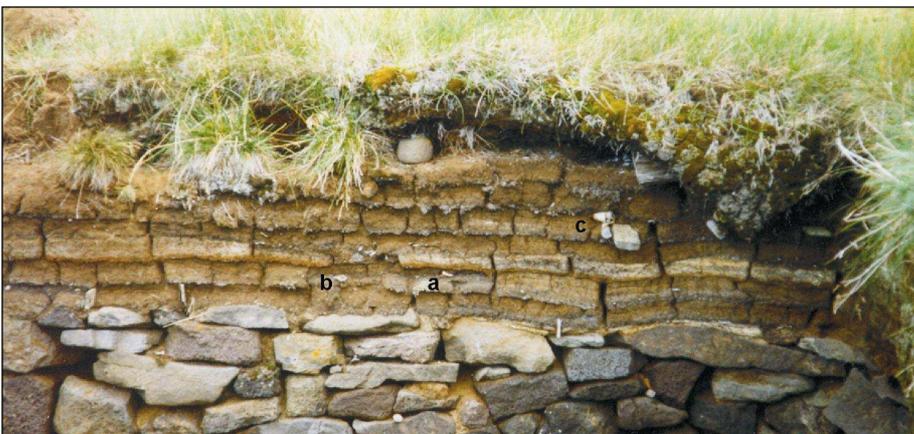
**Figure 2.10** Inner edge of a turf wall in sheephouse 3, the roof of which had collapsed. Note the ceramic fragment (a) and the bone fragments (b, c), which were embedded in the turf when it was cut.

Turf walls often remained upstanding for decades after the roof had collapsed, creating a concave ruin that could act as a trap for windblown sand and silt (Figure 2.10, Figure 2.13). Following the collapse of the roof, the upper layer of turf on the walls was exposed to sunlight and rain and was therefore able to begin growing again (Figure 2.10, Figure 2.13). However, the organic matter in the underlying turves gradually decayed, causing them to shrink, and as they were further degraded by repeated cycles of wetting and drying, and freezing and thawing, the walls gradually lost coherence. Stacks of turf on either the inner or outer faces sometimes separated from the core of the wall and leaned out at a dramatic angle, eventually tumbling under the weight of gravity (e.g. the back wall of the *skemma* in Figure 2.13). The edges of the wall could also slump and ‘melt’ outwards, leaving only the core *in situ* (Figure 2.14). The degradation of their outer skin made the turf walls vulnerable to wind erosion and to abrasion by sheep, which sometimes used them as wind shelters. The erosion face pictured in Figure 2.14 still had tell-tale balls of sheep wool adhering to it.

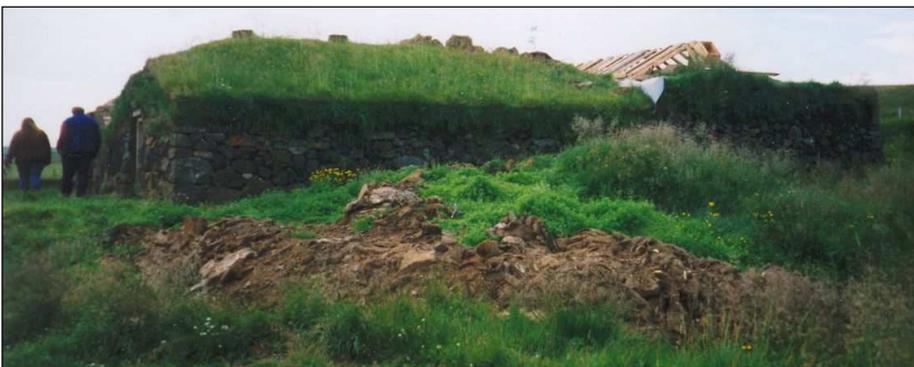
**Figure 2.11** Midden heap containing fragments of turf waste that was produced during the repair of the roof of sheephouse 1.

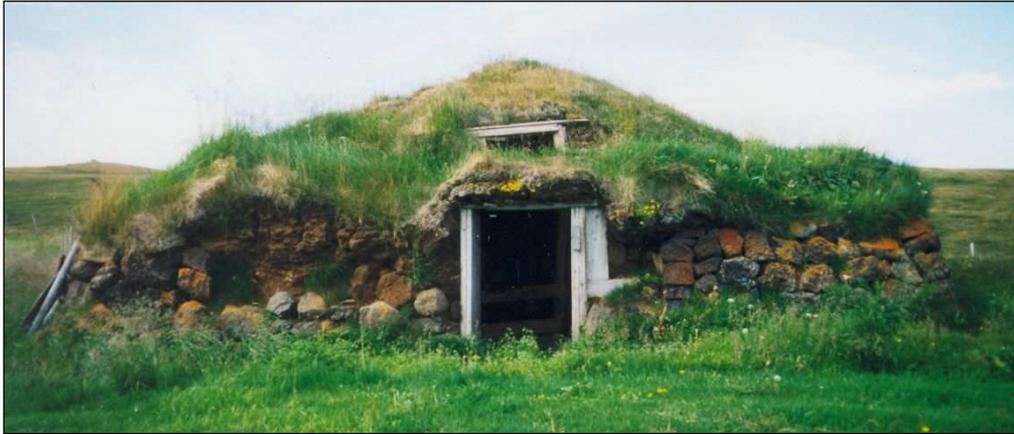
**Figure 2.12** Sheephouse 2, fifty years after abandonment, with its roof still intact, but with an outer skin of stones beginning to peel away. The roof began to collapse two years after this photograph was taken.

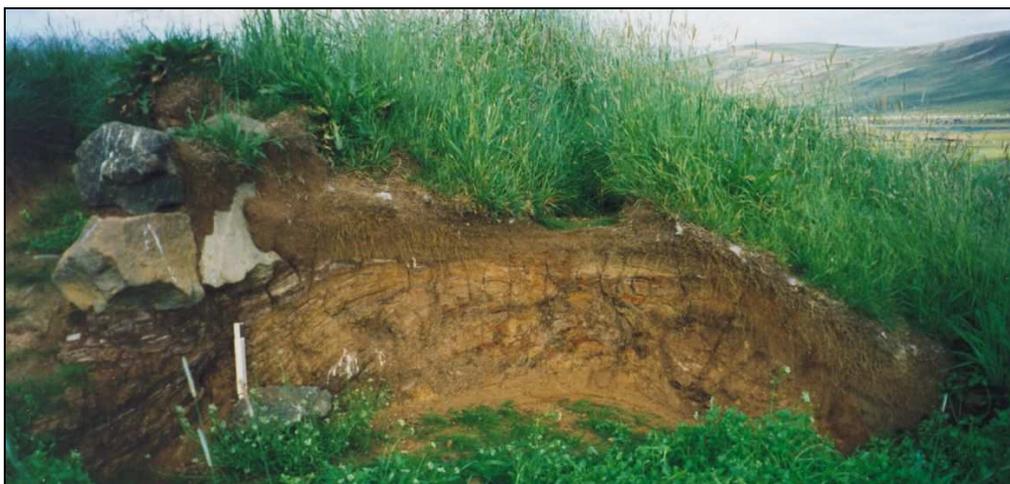
**Figure 2.14** Ruined turf building of unknown age in the infield north of the house. Note the melted aspect of the turfs, which nevertheless show characteristic lenses of oxidised iron (reddish brown), decomposed organic matter (dark brown), and leached soil (very pale brown). The white scale to the left of the photograph is 20 cm long.

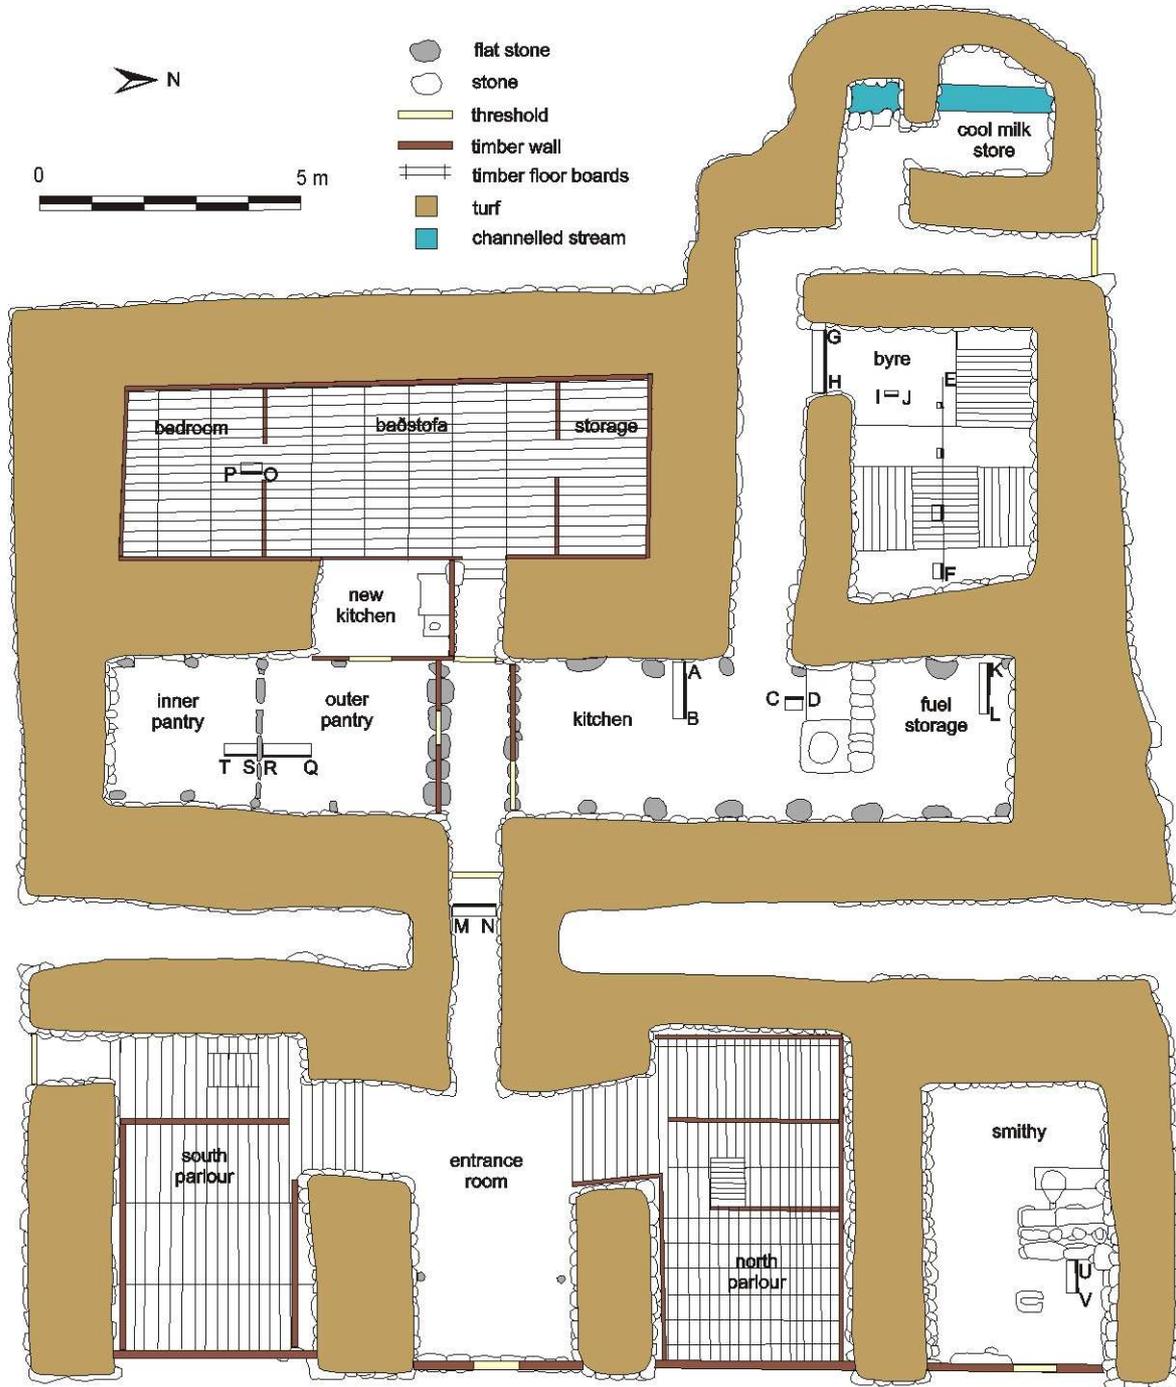
**Figure 2.15** Plan of the turf house at Pverá, showing the locations of the sampling trenches as indicated by letters A-Q (adapted from Oleson and Kjær 1972, 25). Where floorboards were present (indicated by horizontal and vertical lines), samples were taken below the floor boards.

Beyond the entrance hall there is a 1 m-wide corridor (*göng*) that gives access to the main part of the house (Figure 2.15). The central part of this corridor is very ‘hard-trodden’ and compact, but along the walls, out of reach of foot traffic, loose sediment had accumulated (Figure 2.16). Like the entrance room, the heavy traffic in the corridor made it prone to

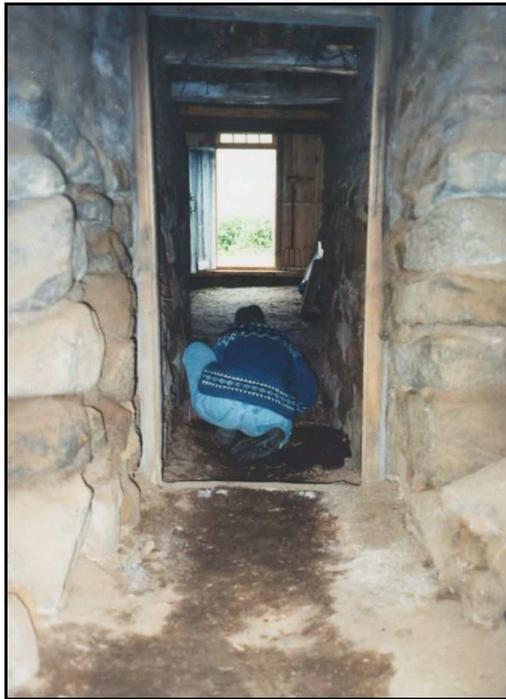
**Figure 2.16** The main corridor (*göng*) at Þverá, facing east towards the front entrance, being sampled for micromorphological analysis. Note that in the central part of the corridor, which receives heavy foot traffic, the floor is moist and compact, while loose, dry sediment has accumulated along the edges of the walls.

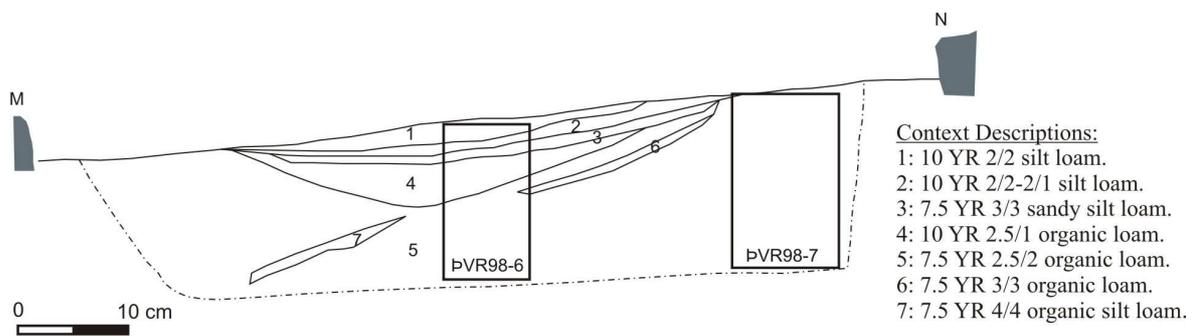
**Figure 2.17** Section drawing of the floor in the main corridor of the house (Section M-N).

In section, the central, trampled part of the floor was marked by a concave depression that had been filled with fine, compact layers of alternating dark brown and brown silt loam (Figure 2.17). Adjacent to the edges of the stone walls, the original ground surface was unaltered. In thin section (sample PVR98-6), it was possible to see that all the layers were composed of turf – that is, the A horizon of an Andosol, containing an abundance of partially decomposed plant fragments. The uppermost 2 cm, which contained the clean, fresh turf that had been laid in the corridor prior to opening the house to the public, had lost the granular or subangular blocky microstructure of natural turf and was so compacted that its microstructure had become massive (no porosity). The brown and dark brown layers of the nineteenth- and early twentieth-century floors were clearly visible in thin section; in fact, the lowermost dark brown layer resolved into two discrete layers, which were separated by another lighter brown one. The lighter brown layers consisted of ‘clean’ turf and contained only the occasional charcoal fragment. The darker brown layers, on the other hand, were heavily stained with dark brown organic pigment and contained highly fragmented charcoal (c. 10%), nodules of heat-oxidised iron (5%), and rare pieces of burnt and unburnt bone, all under 2 mm in size (Figure 2.18). The lighter and darker brown layers also had differing microstructures, with the lower parts of the ‘clean’ turf layers preserving the original subangular blocky structure of the turf and the ‘dirty’ turf layers exhibiting either a prismatic or a platy structure – a good indicator that they were compacted by trampling (Bresson & Zambaux 1990; Courty *et al.* 1994, 259; Davidson *et al.* 1992, 62; Gé *et al.* 1993; Rentzel & Narten 2000).

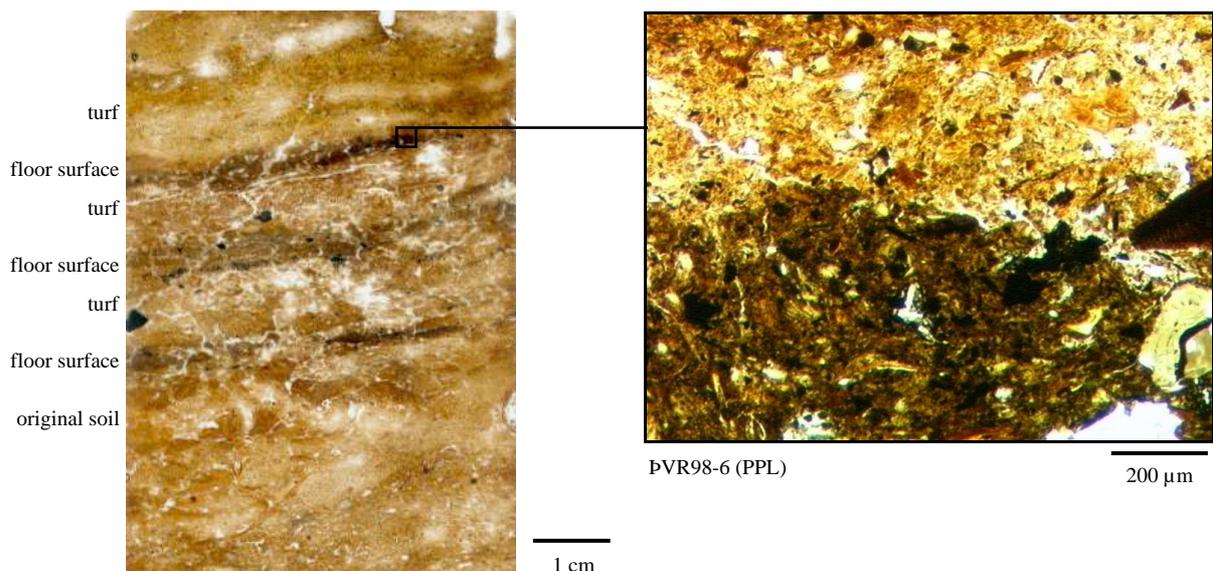
**Figure 2.18** Thin section ÞVR98-6, from the centre of the corridor floor, and a close up of the boundary between a 'dirty', trampled floor surface and the clean turf that had been laid on top of it.

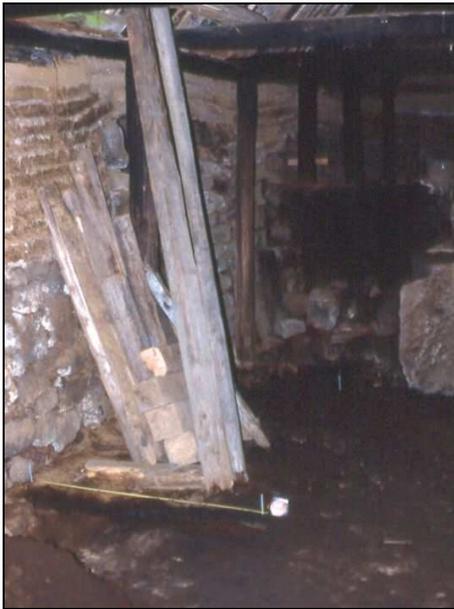
**Figure 2.19** The kitchen at Pverá, from the door, facing northwest towards the hearths. Sampling trench A-B is in the foreground.

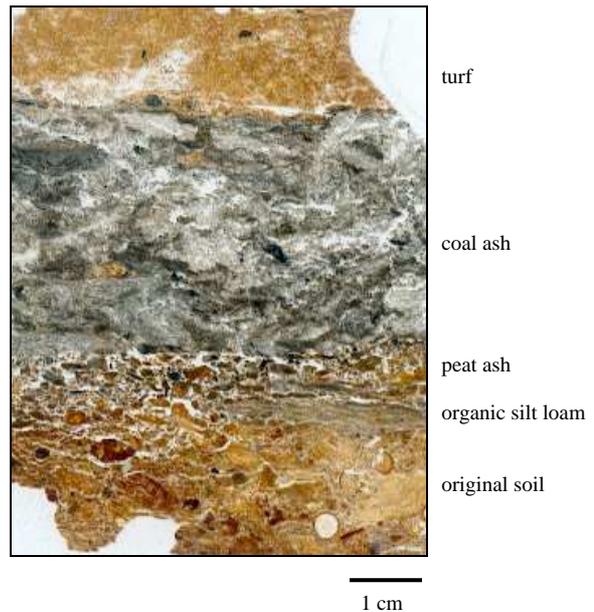
**Figure 2.20** Thin section PVR97-2, from the kitchen floor, showing the thick coal ash layer, and underlying trampled and bioturbated floor surface.

originally had a well-developed platy microstructure, but 75% of it had been reworked by soil fauna (Figure 2.20). In front of the hearth, the floor sediment that had accumulated over the flagstone was characterised by abundant coal ash, wood charcoal, and calcitic wood ash, as well as frequent heat-oxidised iron nodules and occasional fragments of burnt and unburnt bone. Like the other central parts of the kitchen floor, this layer has a well-developed platy structure due to being compacted by trampling.

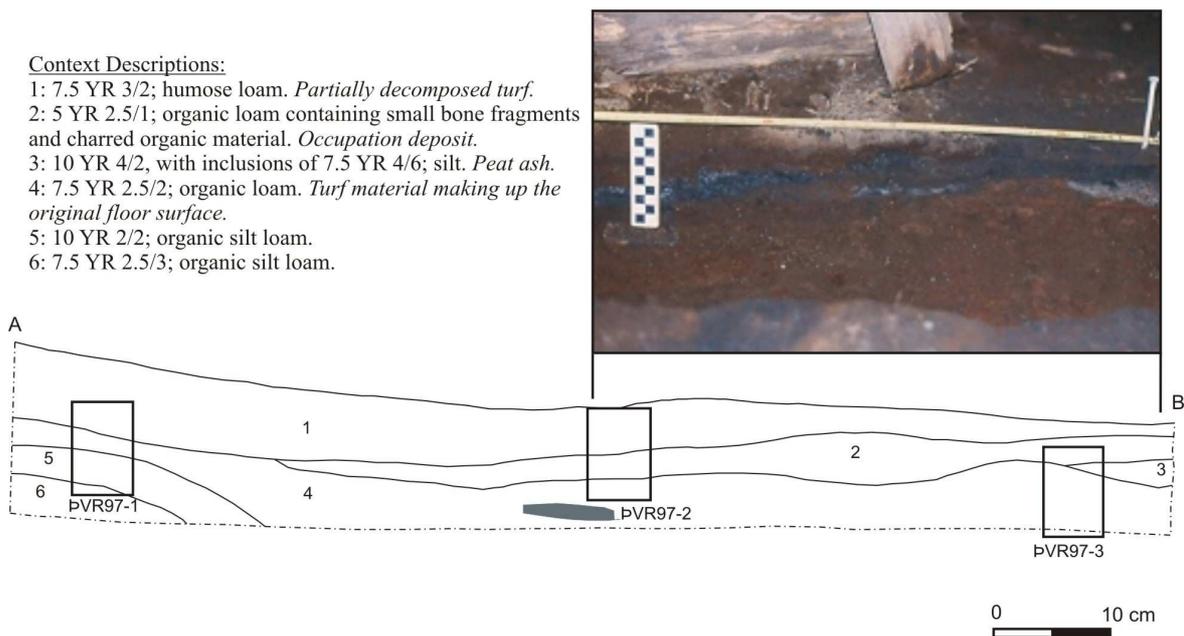
- 1: 7.5 YR 3/2; humose loam. *Partially decomposed turf.*
- 2: 5 YR 2.5/1; organic loam containing small bone fragments and charred organic material. *Occupation deposit.*
- 3: 10 YR 4/2, with inclusions of 7.5 YR 4/6; silt. *Peat ash.*
- 4: 7.5 YR 2.5/2; organic loam. *Turf material making up the original floor surface.*
- 5: 10 YR 2/2; organic silt loam.
- 6: 7.5 YR 2.5/3; organic silt loam.

**Figure 2.21** Photograph and section drawing of the ashy kitchen floor (Section A-B).

Two sampling trenches were placed in the kitchen, one directly in front of the hearth, and one that extended from the middle of the floor to the western wall. In section, the kitchen floor was characterised by layers of pink to grey ash and black charcoal, which covered an undulating soil surface (Figure 2.21). At 30-40 cm from the western wall, the black charcoal-rich layer contained several large pieces of ceramic from a single plate (up to 5 cm in size) that had either broken *in situ* or had been swept there. Towards the centre of the floor the black charcoal layer was up to 5 cm thick, but it thinned out at c. 20 cm from the western wall, and the underlying soil surface took on a more greyish-brown aspect. In front of the hearth the floor sediment was rich in ash and large pieces of charcoal (up to 2 cm in size), and it capped a flagstone that must have been exposed when the hearth was first built.

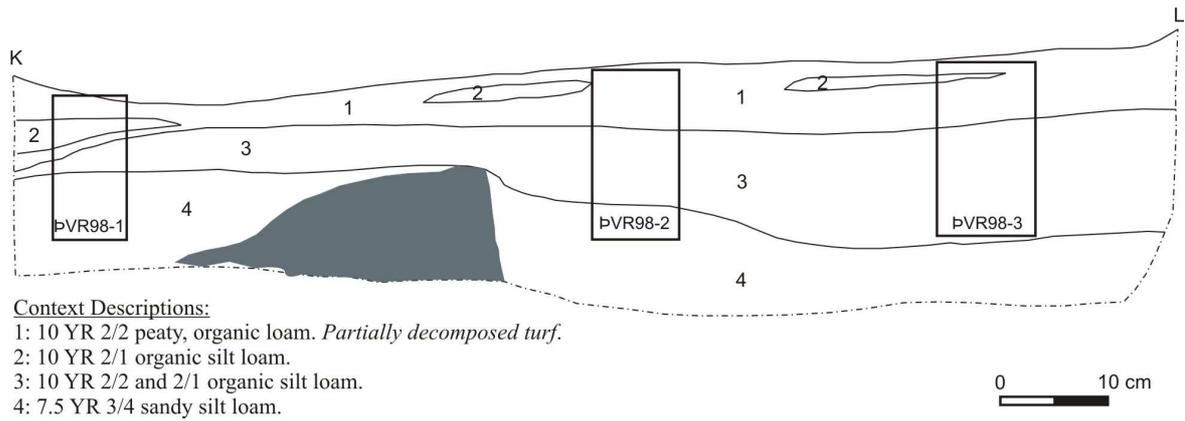
**Figure 2.22** Section drawing of the floor in the fuel storage area (Section K-L).

The sampling trench, which stretched from the middle of the floor to the western wall, did not show any clear floor layers in the field (Figure 2.22). In thin section, however, it was possible to see that the uppermost sediment horizons in the middle of the storage area contained a moderately- to well-developed platy microstructure – good evidence of compaction by trampling. It was also possible to identify the residues of the fuels that had been stored in this area. These included a lens of fine coal fragments, fresh wood fragments, an aggregate of herbivore dung, which contained abundant faecal spherulites, and lenses of peat, which contained horizontally bedded phytoliths (see Figure 2.23). It is notable that the thin section taken adjacent to the west wall (PVR98-1) did not exhibit any structural indicators of trampling and also contained coal fragments up to 8 mm in size, while all the coal fragments in the sample taken from the middle of the room were below 2 mm in size. This size sorting is probably a product of the ‘edge effect’ noted by several ethnoarchaeologists, in which larger objects tend to be kicked out of areas of heavy foot traffic, and accumulate on the edges of the trampled areas (e.g. Wilk & Schiffer 1979, 533).

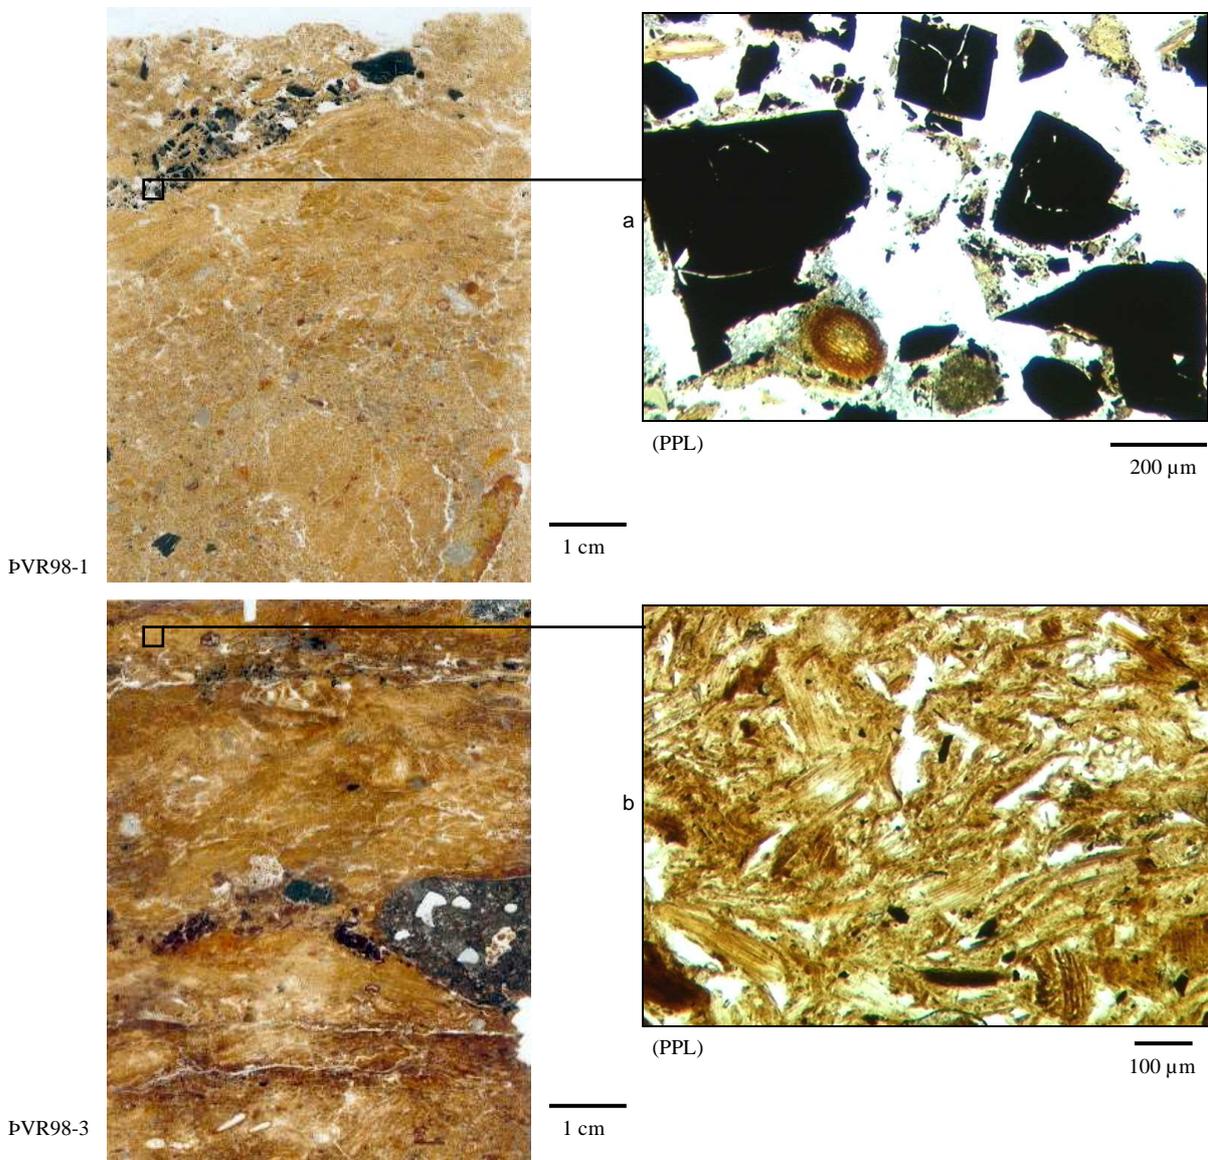
**Figure 2.23** Thin sections PVR98-1 and PVR98-3, from the fuel storage area, and micrographs showing some of the fuel residues: (a) coal; (b) herbivore dung, which contained chopped plant tissues and which was identical to reference samples from the cattle byre and sheepphouse.

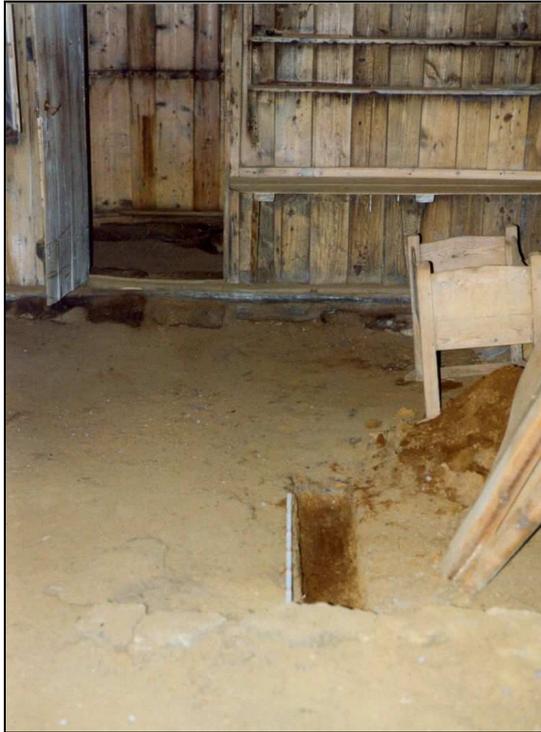
**Figure 2.24** Photograph of the outer pantry (*búr*), facing north, showing the door and its stone threshold. In the foreground is the line of stones that had been the foundations for a wooden partition wall.

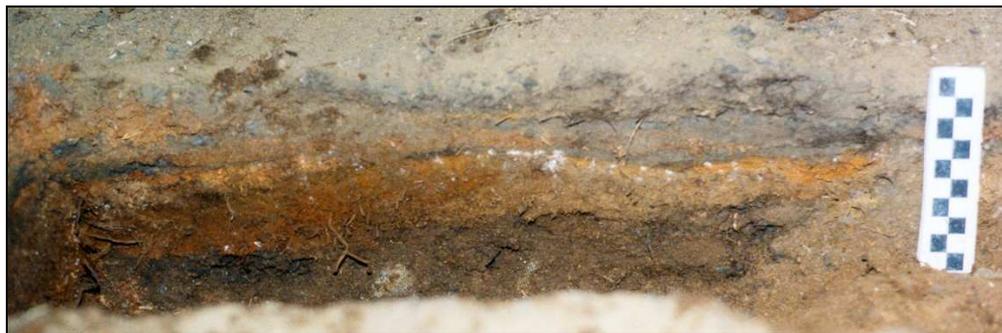
**Figure 2.25** Section through the floor in the outer pantry, showing the interdigitating layers of turf and ash.

Sampling trenches were opened both to the north and to the south of the former partition wall. In section, the floors were characterised by fine brown, reddish brown, and dark brown peaty turf (organic silt loam) layers, which interdigitated with uneven and discontinuous layers of ash and charcoal (Figure 2.25). In thin section (sample ÞVR98-26), the dark brown silt loam layers of the outer pantry contained organic pigmentation, an abundance of silt-sized organic residues, highly fragmented charcoal and coal (<1.5 mm), horizontally oriented plant tissues and amorphous organic matter, occasional fragments of burnt bone (<2 mm) and heat-oxidised iron nodules, and one nut shell fragment. This layer had a very well-developed platy structure, and was undoubtedly a trampled occupation surface (Figure 2.26). At the bottom of this trampled surface there was a layer of large charcoal fragments up to 1.5 mm in size, which must have been intentionally dumped. The trampled floor layer was capped by two layers of very peaty turf, which were distinguished by a sharp boundary and an abundance of red oxidised iron in the lower turf layer. These turf layers had clearly been intentionally laid and can be associated with the practice of periodic turf deposition that was described by Áskell.

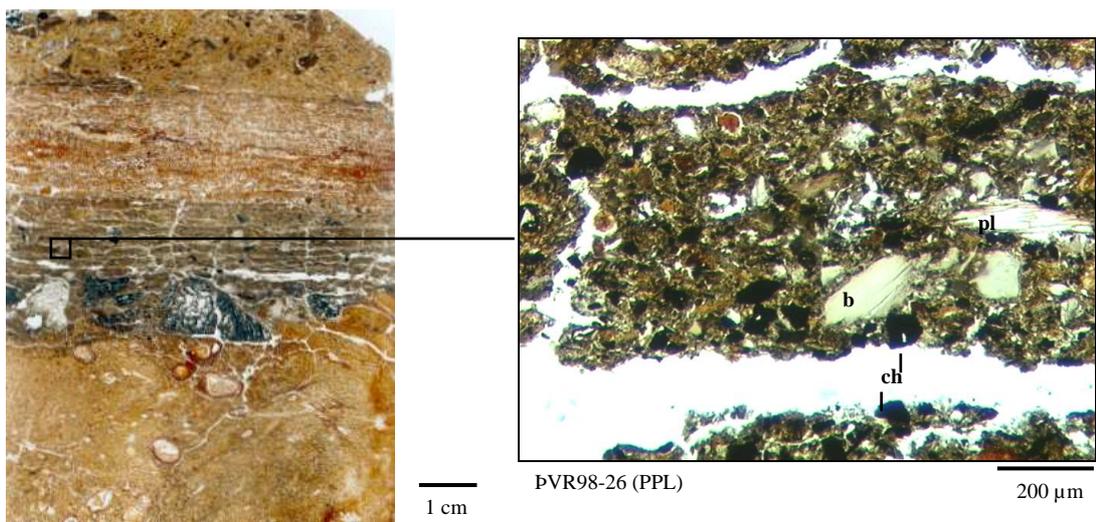
**Figure 2.26** Thin section PVR98-26, from the outer pantry, and a micrograph of the trampled floor surface. Note the platy structure, bone fragment (b), plant tissue (pl), and charcoal fragments (ch).

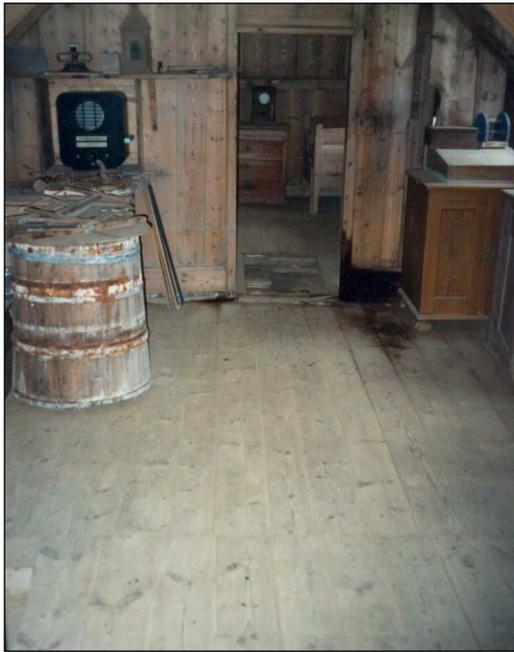
**Figure 2.27** The sitting/sleeping room, facing south into the bedroom. Loose sand was found in the cavity below the floorboards.

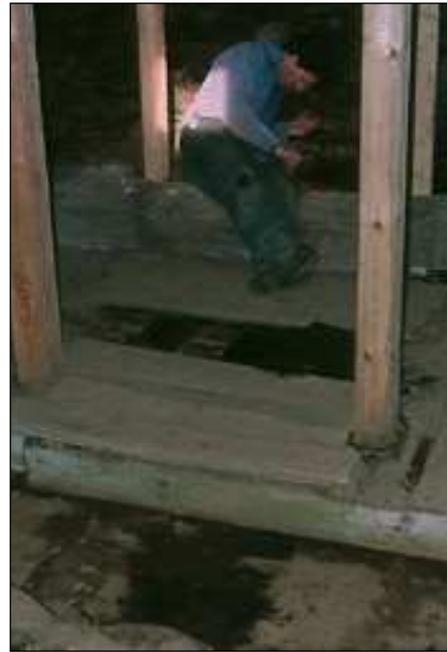
**Figure 2.28** The cattle byre, facing northeast, showing the stalls, feeding trough, and dung channel being sampled.

be removed in order to make it easier to shovel out the dung (Figure 2.28). The floors of the stalls are currently covered with wooden floorboards, but when Áskell was a child they had been covered with flag stones at the front and turf at the back. Like the turf floor coverings in the main part of the house, the turf bedding in the cattle byre could be easily cleaned out and replaced. The floors and dung channel had been regularly sprinkled with ash in order to absorb moisture and to mask odours.

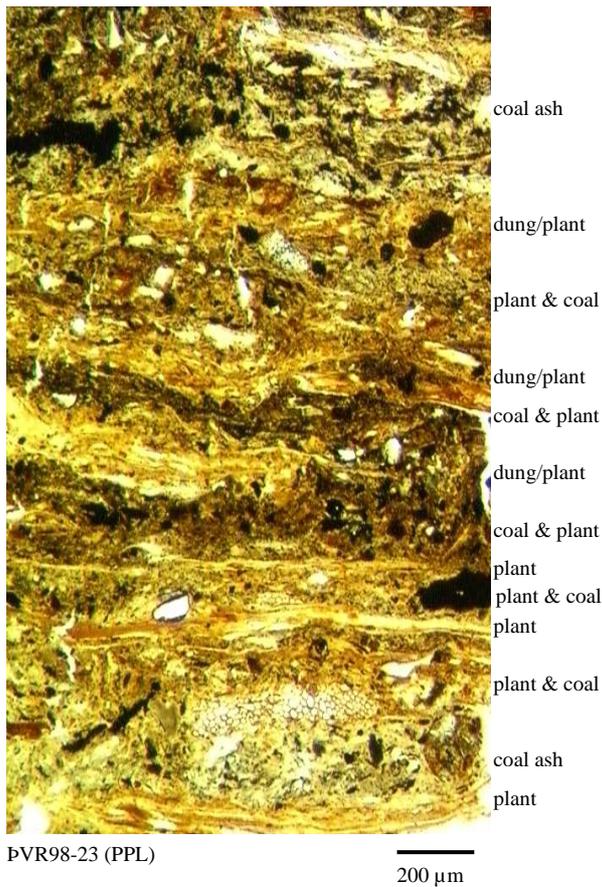
**Figure 2.29** Horizontal bedding of dung, herbaceous plant, and coal ash in the cattle byre.

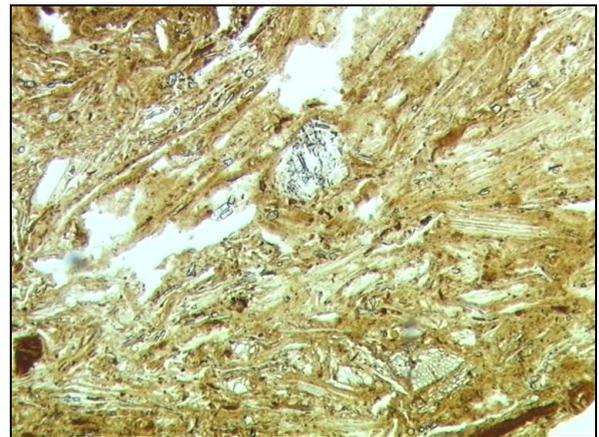
**Figure 2.30** Examples of dung lenses in the cattle byre; they consist of chopped plant tissues.

Discrete dung lenses were readily identifiable and consisted of herbaceous plant tissues and associated phytoliths embedded in amorphous organic matter (Figure 2.30). The plant tissues varied in length, but had a distinct, 'chopped' appearance, often with broken, squared ends. The shorter plant tissues were randomly oriented, but longer strands were predominantly horizontally or sub-horizontally aligned, a pattern that has been observed in other modern reference samples of cattle dung (see Appendix 3, Table A3.3). Hay layers consisted of long strands of horizontally bedded plant tissues and associated phytoliths embedded in amorphous organic matter, and in certain heavily compacted layers it was difficult to tell if the horizontally bedded plant matter was derived from cattle dung, hay, or a combination of the two (a difficulty also noted by Heathcote 2004).

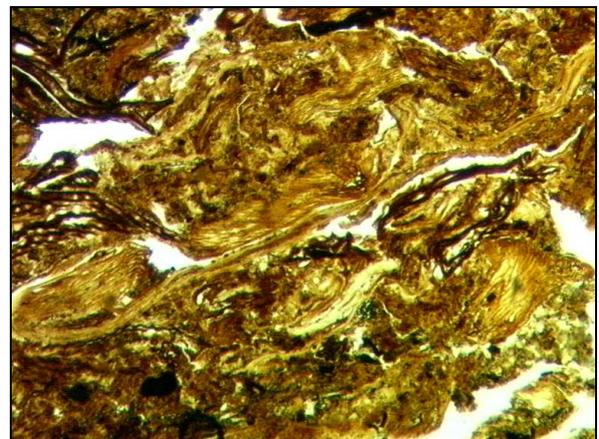
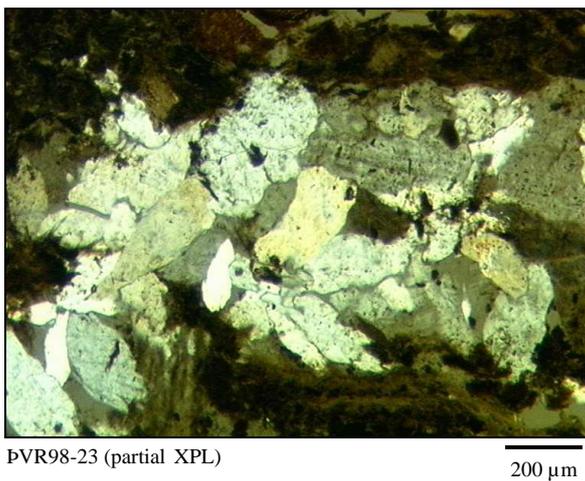
**Figure 2.31** Hypidiotopic gypsum infilling of a planar void at the bottom of the byre sequence.

At the bottom of the floor sequence in the cattle byre, the long, horizontal planar voids that separated the platy peds were infilled with gypsum ( $\text{CaSO}_4 \cdot 2\text{H}_2\text{O}$ ; Figure 2.31). Such crystalline pedofeatures are normally associated with arid conditions and, to my knowledge, this is the first time that they have been observed in stabling deposits in temperate or maritime environments. Like the neo-formed calcium carbonate crystals, these gypsum infillings are likely to derive from calcium mobilised higher up the profile, which was carried downwards by a wetting front. There are abundant sources of calcium in these deposits, including plant matter, ash, and the cattle excreta, which may in fact have originally contained faecal spherulites (Canti 1999; Cook & Heizer 1965). Considering that the byre was roofed and protected from rain, the percolating liquid that caused this downward redistribution of calcium was most likely urine rather than water.

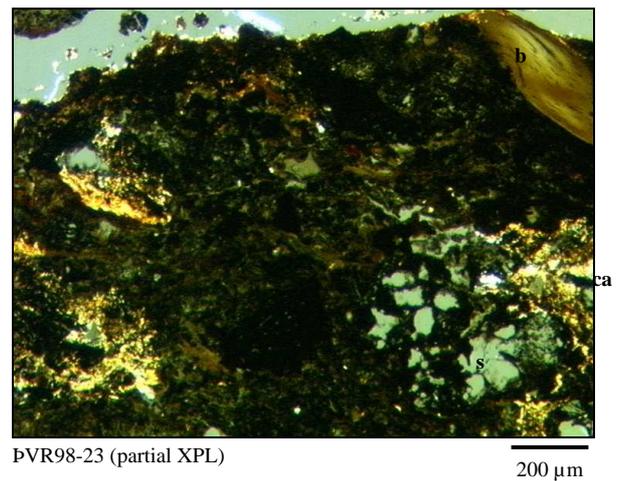
**Figure 2.32** Micritic calcium carbonate coatings and crystal intergrowths (ca) in a lens dominated by coal ash and amorphous organic matter. Note also the bone fragment (b) and the vesicular globule of non-metallurgical slag (s).

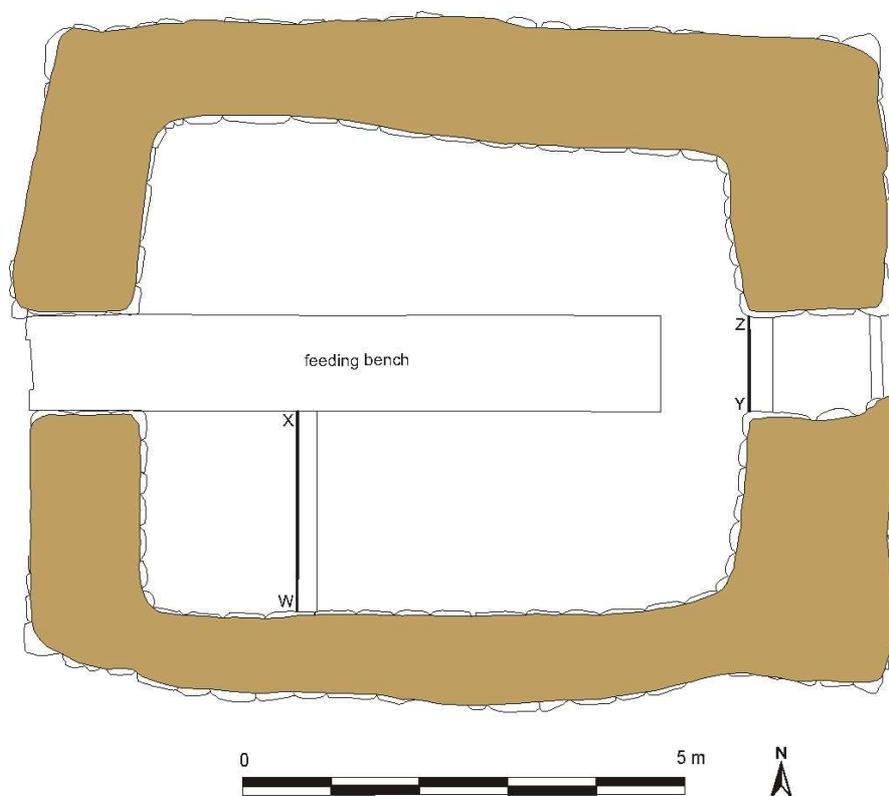
**Figure 2.33** Plan of sheephouse 2 with the location of the sampling trenches indicated by the letters W-Z.

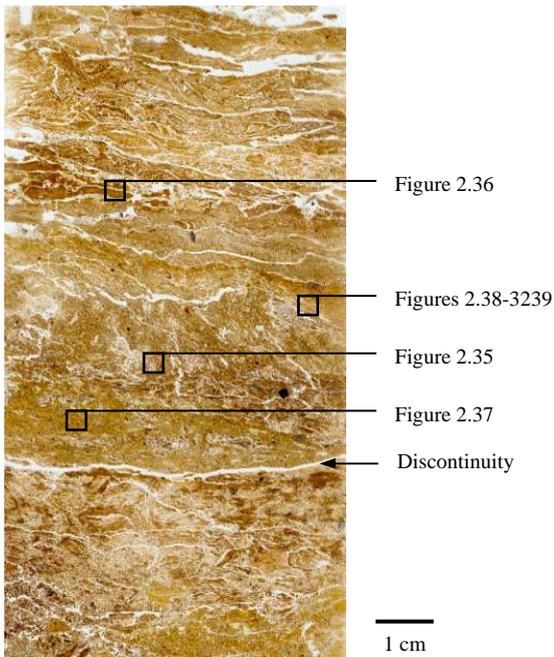
**Figure 2.34** Thin section PVR99-1, from the floor of the sheephouse. It contains a sequence of dung, hay, and soil deposits.

It should also be noted that the organic matter that comprised the floor sediments in the sheephouse was highly palatable to soil fauna and had encouraged post-depositional bioturbation. The lower third of sample PVR99-1 in particular (the portion of the sequence below the discontinuity) had been heavily reworked, so that only c. 30% of the original fabric had survived (Figure 2.34). While the pockets of original fabric showed the characteristic horizontal orientation of plant tissues, the reworked groundmass consisted only of organic-rich faunal excrements, in which the original organisation of the sediment had been destroyed. It would therefore be realistic to expect organic-rich sediments in the archaeological record, especially those associated with animal stabling areas, to be reworked by soil fauna. In such cases it would be difficult to distinguish horizontal bedding in the field, and it would probably require a high resolution technique such as thin section micromorphology to identify the original organisation and composition of the sediment.

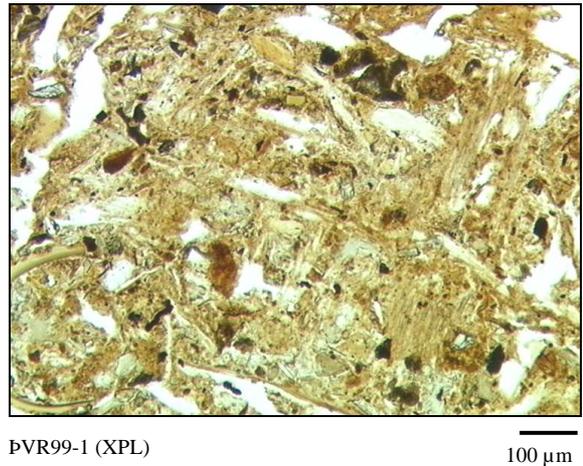
**Figure 2.35** Sheep dung. Note the randomly oriented plant tissues, often truncated, with squared ends, and associated phytoliths.

The layers of sheep dung did not contain any faecal spherulites, but were readily identifiable on the basis of their organic composition: short segments of 'chopped' plant tissues and associated silica phytoliths, which were randomly oriented and embedded in amorphous organic matter (Figure 2.35). The sheep dung at Pverá therefore bore a close resemblance to other modern analogues of sheep dung observed by myself and other researchers (cf. Appendix 3, Table A3.3, p. 345). As in the cattle byre, the layers that consisted of very long, horizontally bedded plant tissues were easily identified as hay, but the plant tissues in more reworked layers could have been derived from either dung or hay.

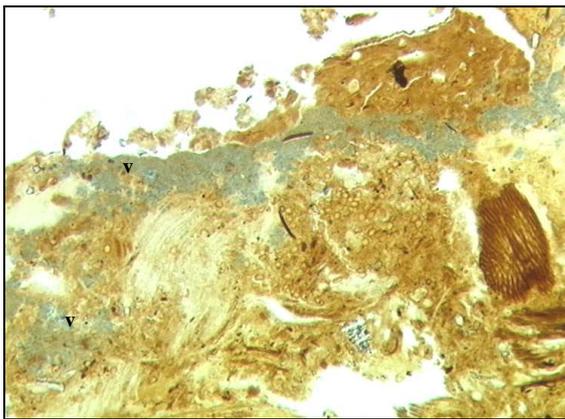
**Figure 2.36** Hypocoating and intergrowths of vivianite (small blue crystals; labelled 'v').

One localised area in the floor sequence also contained vivianite, a compound of iron and phosphate ( $\text{Fe}_3(\text{PO}_4)_2 \cdot 8\text{H}_2\text{O}$ ) that forms under reducing conditions when there is an abundance of available iron and phosphorus. The vivianite crystals, which had oxidised when the samples were taken, were readily identifiable on the basis of their blue colour and pleochroism in plane-polarised light. They were present in the form of discontinuous hypocoatings around large planar voids and crystal intergrowths in the organic groundmass (Figure 2.36). Because the formation of vivianite depends on an availability of phosphorus, it is not uncommon to find it in bogs. In archaeological contexts it has been observed in waterlogged cess deposits and organic-rich occupation deposits subjected to periodic or prolonged waterlogging (Gebhardt & Langhor 1999; Landuydt 1990; Milek 1996). Its formation in the sheephouse at Pverá is a result of the abundance of phosphate-rich sheep dung and plant matter, and is further evidence that localised reducing conditions occurred in the floor deposits. Since the farm buildings at Pverá are located on a well-drained slope, these reducing conditions must have been created by the build-up of organic matter on the floor of the sheephouse and the input of urine during the winter months when the sheep were housed there.
