# ICELANDIC TURF BUILDINGS: FLOOR FORMATION PROCESSES AND THE INTERPRETATION OF ACTIVITY AREAS

## **2.2 ETHNO-GEOARCHAEOLOGICAL CASE STUDY: ÞVERÁ, LAXÁRDALUR**

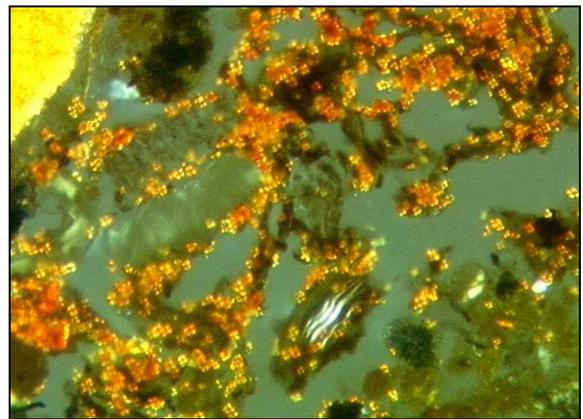
**Figure 2.37** Spherulites of siderite.

A number of unusual crystalline pedofeatures were observed in the sheephouse sediments. A layer of organic silt loam in the middle of the sequence contained several clusters of spherulitic siderite: small crystals, 5-10 µm in diameter, of iron carbonate ( $\text{FeCO}_3$ ), which appeared reddish brown in PPL and yellow to orange in XPL due to their iron content, and which have a distinctive extinction cross in XPL due to their spherulitic shape (Figure

2.37). Spherulitic siderite forms in reducing conditions – it is common in bogs, for instance (Landuydt 1990) – and has been found in waterlogged occupation deposits (Gebhardt & Langohr 1996). Its presence in the sheephouse at Pverá indicates that localised reducing conditions occurred in the sealed floor layers, either because they were occasionally saturated by urine, or because bacterial decomposition of the abundant organic matter eventually used up all of the available oxygen.

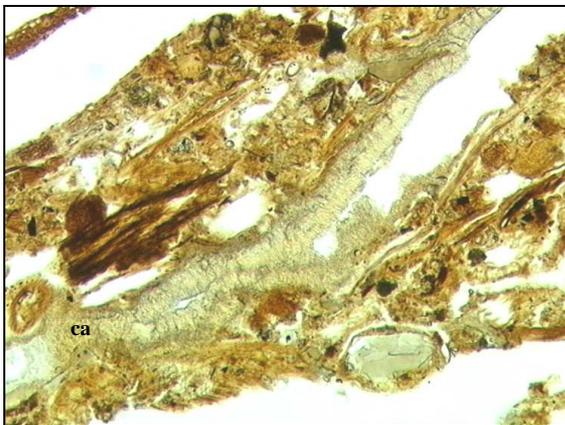
**Figure 2.38** Infilling of calcium carbonate.

As in the cattle byre, the flow of liquid through the floors of the sheephouse resulted in the mobilisation of calcium and the localised precipitation of calcium carbonate ( $\text{CaCO}_3$ ) in the form of coatings and infillings in voids. In the sheephouse, however, the crystals were not only in the form of micrite, but were sometimes larger, lathe-shaped, and oriented perpendicular to the walls of the voids (Figure 2.38; Figure 2.39). The calcium could have derived from either the plant material in the bedding (i.e. hay) or animal excreta, or both (Cook & Heizer 1965, 19).

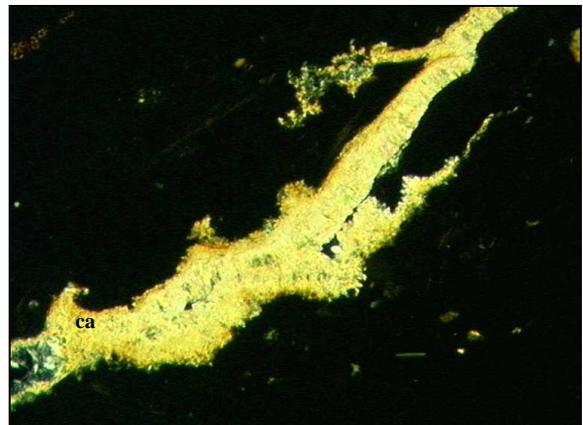
**Figure 2.39** As Figure 2.38, but in XPL.
