ÞVERÁ, LAXÁRDALUR

Preliminary Report on a Sampling Project for an Ethno-Archaeoentomological Investigation

Véronique Forbes and Karen Milek

21.07.11

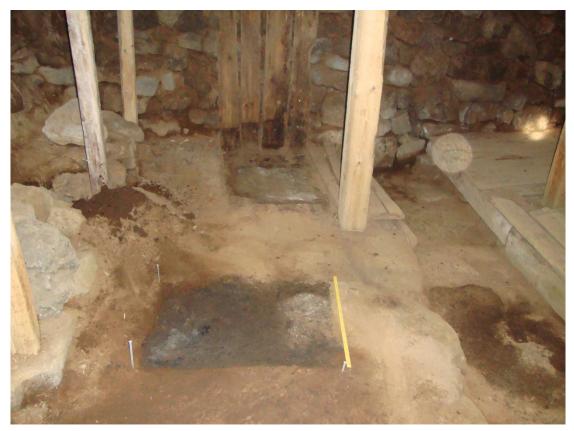
Figure 9. Photograph of the western part of the cattle byre showing the location of sampling trenches 3 (the drain on the right), 4 (top) and 5 (bottom). Camera facing

additional stalls had been removed (Milek 2006, 59). The first trench we excavated in this room was sampling trench 3, which consisted in the drain located in the center and which originally served to collect dung and urine (see fig. 9). Four litres of loose humose silt that had accumulated between the stones on the bottom of the drain were collected (sample S- 8). These sediments contained grass fibres and a few twigs.

A sampling trench was placed underneath the wooden floor boards in the northwestern corner of the cattle byre (see fig. 9). The sediment was extremely organic and composed of hay remains with a high content of decayed wood originating from the floor boards. It is possible that this layer corresponds to an older wooden floor, the wood being in an advanced state of decomposition. This layer (context 10), which was the only one excavated in this trench, was 2-3 cm thick and was bottomed by a very large flat stone (see fig. 7). A single sample was taken from this context (S-9).

A third sampling trench was placed in the cattle byre, in the hard-packed earthen floor west of the drain (see fig. 9). Two floor layers were excavated there. The first one (context 11) was very compact and multi-laminated, but less so on the western edge of the trench, where it was also thicker (up to 2 cm). It was composed of very organic silt, from which one sample was taken (S-10). This deposit had a very sharp boundary with the layer below (context 14) which contained a flat stone in its NE corner. Context 14 was also a very compact and organic floor devoid of inclusions. Only 1cm of the layer was excavated to allow the collection of a sediment sample (S-11). The thickness of the layer is unknown, but it was more compact in the centre of the trench than it was close to the western edge.

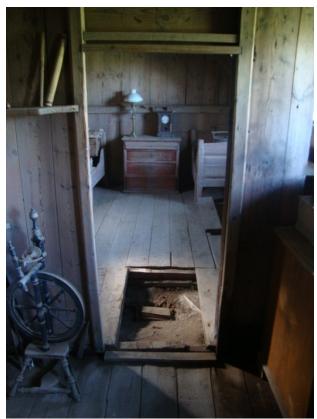
Figure 10. Photograph taken in the *baðstofa* showing the location of sampling trench 7. Camera facing south.

The seventh sampling trench was located in the bedroom, in the southern side of the baðstofa. It was placed in the sediments c. 10 cm below the wooden floor boards (fig. 10). The first context (16) to be excavated was composed of very soft and loose sandy silt, which contained bits of decomposed paper, wood chips and white ash flecks. The context had been truncated in the middle of the trench by the sampling trench excavated by Milek in 1997 to collected Karen micromorphology samples. Two samples were collected from this context (S-13 and S-17). A number of finds were recovered from these sediments: three buttons, two nails, one vessel glass fragment, three pieces of wooden objects and seven pieces of paper. Below this layer was another accumulation of dust (context 20), this time light reddish and vellowish brown and with few wood chips inclusions. This layer was 2-3 cm thick and also truncated by the 1997 sampling trench. A sediment sample was collected from this context (S-18). The removal of context 20 revealed a series of deposits composed of soft

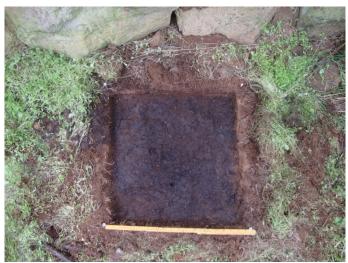
Figure 13. Photograph of sampling trench 11 after the removal of context 28.

Then eleventh trench was placed inside the abandoned and partially collapsed sheep house 1, in its southwestern corner. The first context to be excavated (context 27) was turf collapse, probably originating from the roof as it contained bits of structural timber and birch twigs. Underneath was a 3 cm thick floor layer (context 28), which corresponded to the use of the sheephouse, as it was formed of humose silt, a mixture of trampled sheep dung and laid turf. Sample S-23 was collected from this layer. Context 28 was overlying another floor layer (context 29), this time uniformly composed of trampled sheep dung. Two cm of this layer were excavated to allow
